Subject: 2012 Trophic Status Index Mapping Flight Report

On August 2, 2012 AWRL conducted a TSI Mapping Flight of Lake Shamineau (MN ID# 49-0127) in Morrison County, Minnesota.

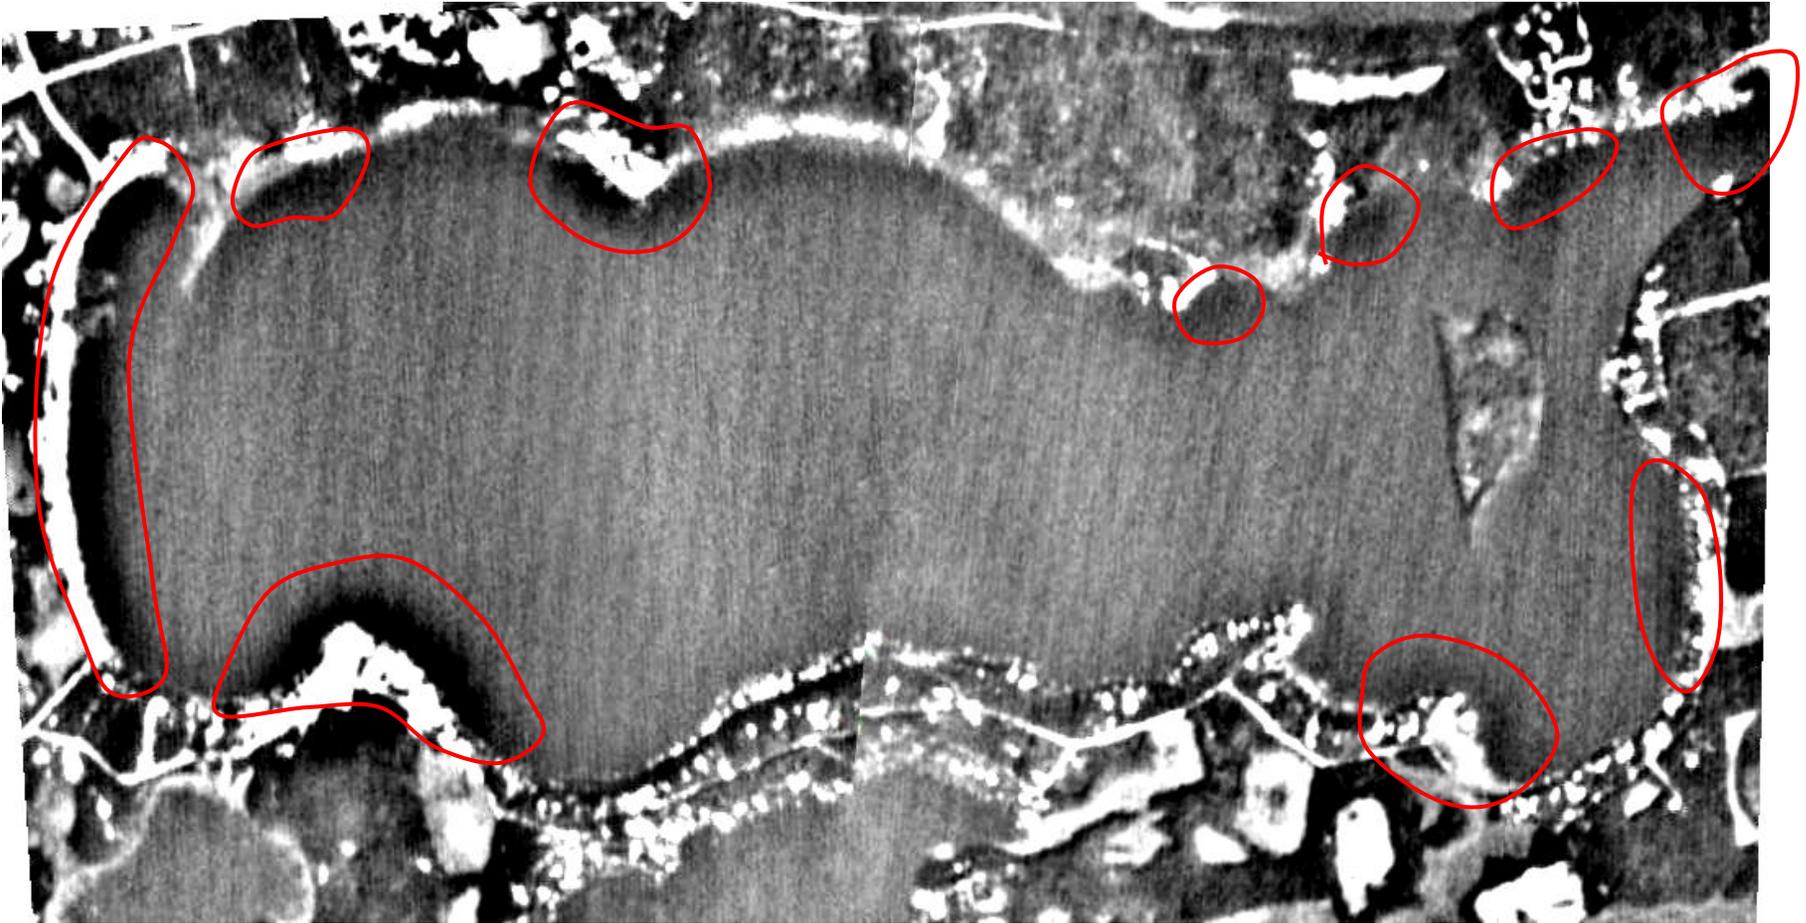
Thermal Image

Areas circled in red indicate cooler water entering the lake, potentially from groundwater springs or septic systems.

White = Warm
Dark = Cool

The large area of concern along the western shoreline, labeled #1, is likely caused by nutrient loading from leaking septic systems or springs. The thermal image shows the potential for groundwater springs in this area. Particular attention should be paid to the bright red and orange stretch on the north shore of the lake in this area.

Leaking septic systems and/or springs are the most likely cause of the high TSI values at areas of concern #3, #4 and #5. The thermal image also indicates spring activity in these locations.

Conduct a Groundwater Intrusion Overflight (GWI) of the areas of concern (approximately 5 miles of shoreline) in the winter of 2012-2013 to pinpoint problem septic systems and springs that are influencing the lake. The information from the flight will then be used to mitigate these nutrient sources problems and stop the nutrient loading at the source. AWRL can provide a detailed proposal if you are interested in pursuing this project.

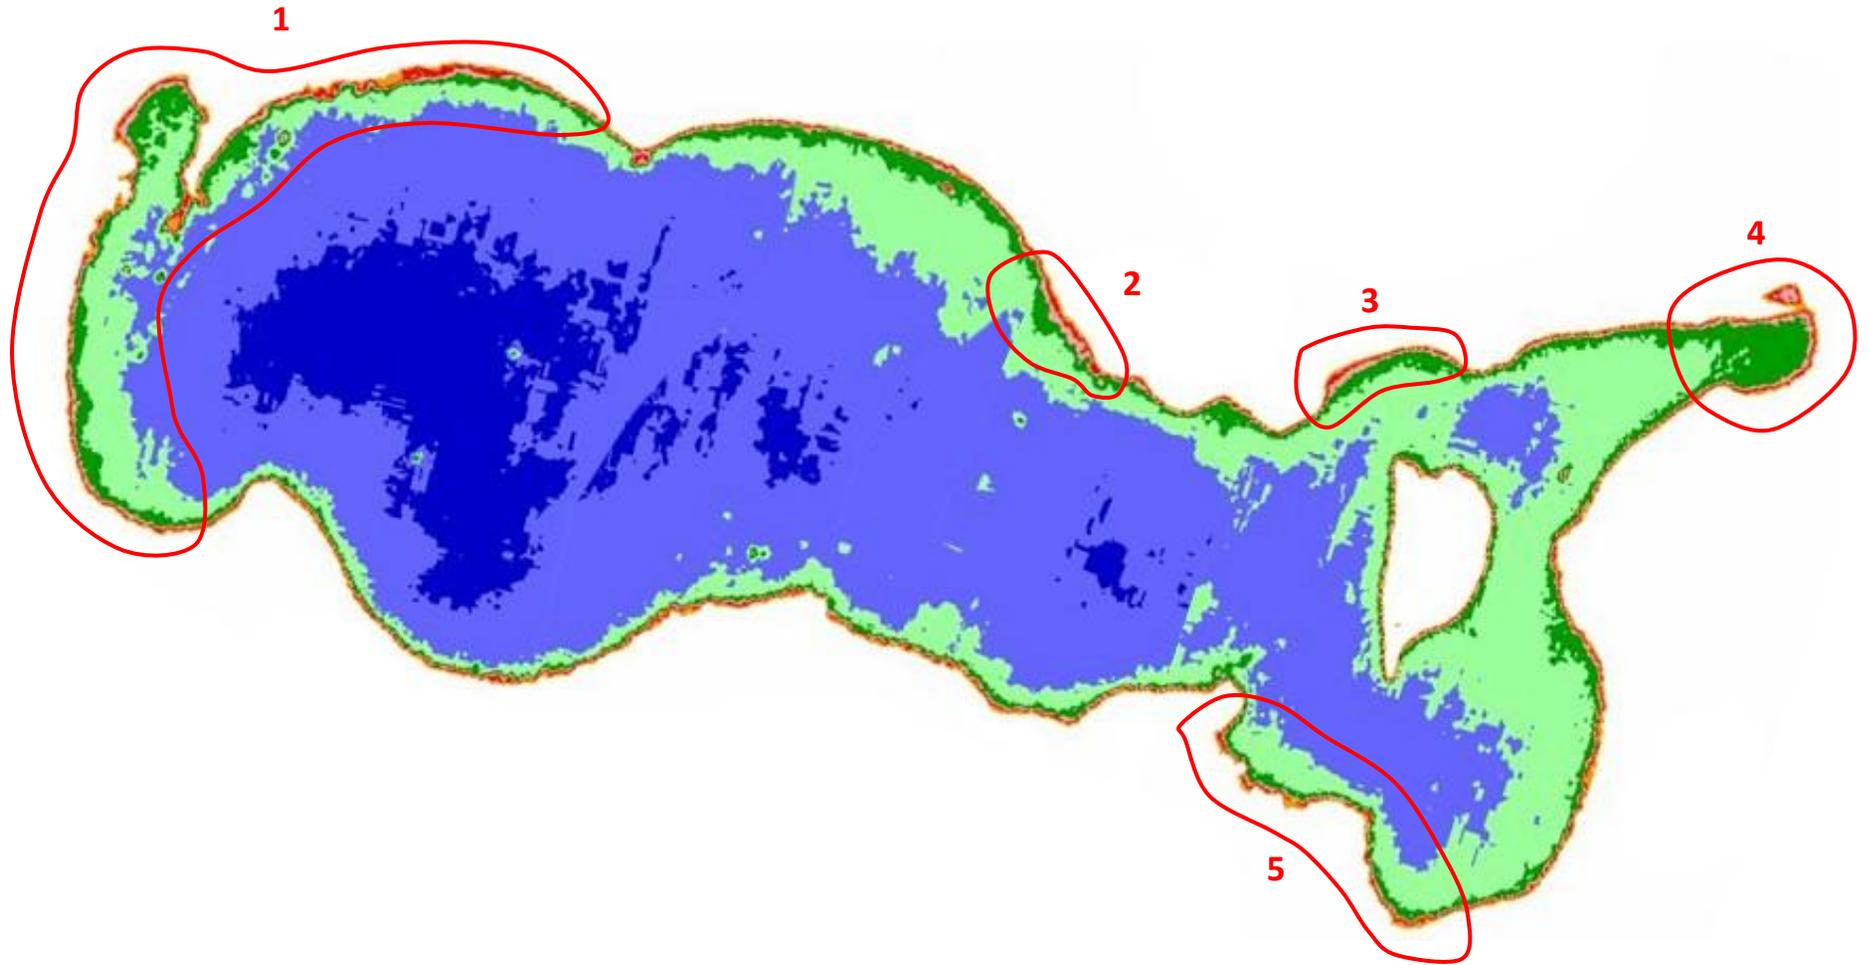
Red circled areas indicate priority areas of concern.

The TSI Map for Lake Shamineau shows TSI values ranging from 31-50 for the majority of the lake with higher TSI values (51-100) occurring near the shoreline areas. This is due to the fact that in general, the majority of nutrient loading occurs near the shoreline where runoff from roads, lawns and septic leaks from shoreline properties enter the lake.

There are a few areas where this loading is heavier that have been circled in red on the TSI Map above. These areas show a progression from Mesotrophic (light green), to Eutrophic (dark green and red), to Hypereutrophic (orange) as you move closer to the shoreline.

Area of concern #2 shows some evidence of emergent vegetation and algae problems. The TSI Map indicates that there are a higher amount of nutrients in this location, which would support more vegetative growth. The sources of the higher nutrients in this location should be investigated further.

A volunteer committee should be formed to conduct basic groundtruthing in the areas circled in red on the TSI Map to determine what potential sources (i.e. runoff, springs, or point discharge) could be contributing to the higher TSI values in these areas. Groundtruthing is a simple process that involves visiting the property of concern and working with the property owner to locate, identify and fix any found issues. Many problems, once discovered, may be a quick fix on the part of the property owner.
